# HISTORIC STRUCTURAL ASSESSMENT

1013 LaFARGE AVENUE, LOUISVILLE, COLORADO

September 23, 2025

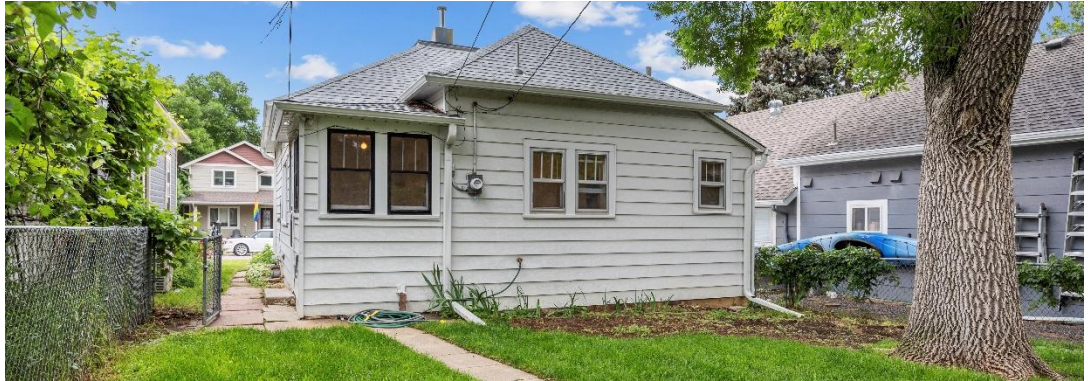
The overall site grading is in poor condition. It is important that the grading around the house should be a minimum of six inches below the top of the foundation and slope away from the foundation for at least the first five feet. Due to the nature of the lot, it is difficult to meet these requirements without a large amount of regrading or lifting the building and pouring a new foundation.

*Grade is highest at the northwest corner of the house where finish materials are in contact with grade.*

2. The top of the foundation relative to the top of grade should be determined around the entire perimeter of the house. If the top of the foundation is determined to be at or below the existing grade, new grading should occur to bring the grade down below the top of the foundation, as prescribed by a licensed structural engineer.

3. Finished grade around the house perimeter should be re-graded to create positive drainage away from the house. The top of finished grade should be a minimum of six inches below the top of the foundation and slope away from the foundation for at least the first five feet. Coordinate slope with a licensed geotechnical engineer.

4. The house foundation should be replaced to bring the top of foundation at least six inches above finished grade. Coordinate with a licensed structural engineer and a licensed geotechnical engineer.

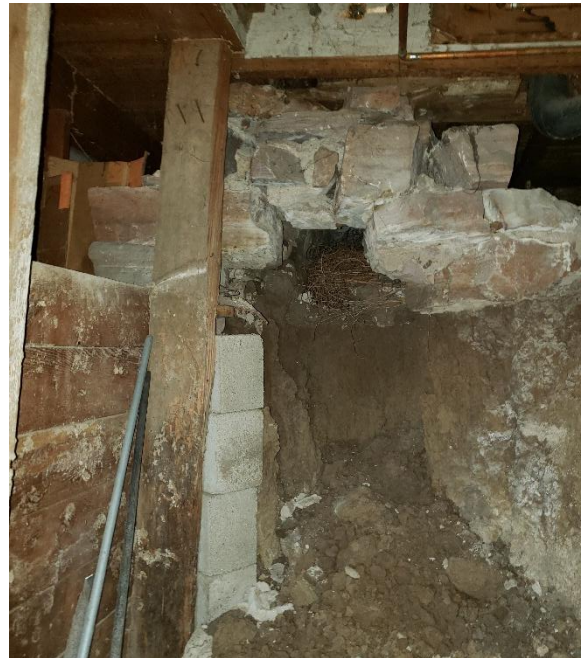
*Original stone foundation undercut by sluffing soil.*

There are several areas where the basement was dug out directly beneath or near to the original crawlspace depth foundation walls. These areas are not properly supported and undermine the original foundations. Some of these locations have sheer cut soil where sluffing has occurred, completely undermining the foundation, particularly along the north and south walls of the original house.

4. Retaining walls and foundation repair is necessary to address the areas where the foundation has been undermined by sheer cut soil to create the basement area. Work with a licensed structural engineer for further evaluation and a design strategy that will likely include the construction of new retaining walls. The soil cut portion should be temporarily braced until a retaining wall can be designed and built.

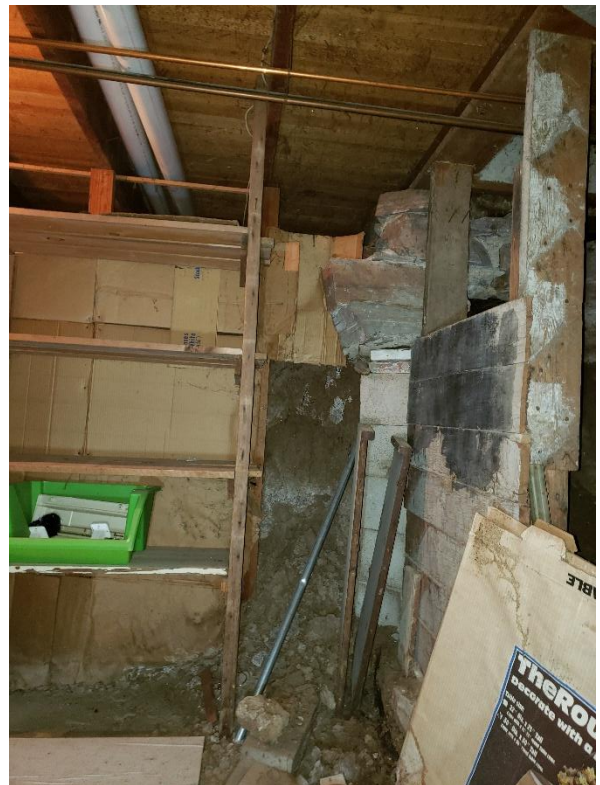
*Attempt at soil retention using wood framing and cardboard.*

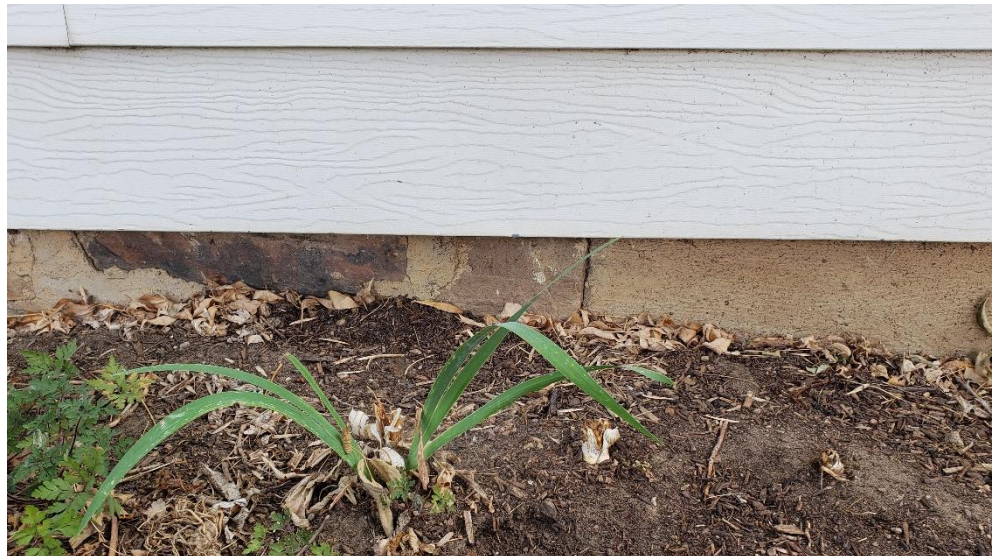
*Exterior view of transition from stone foundation (left) to concrete foundation (right).*

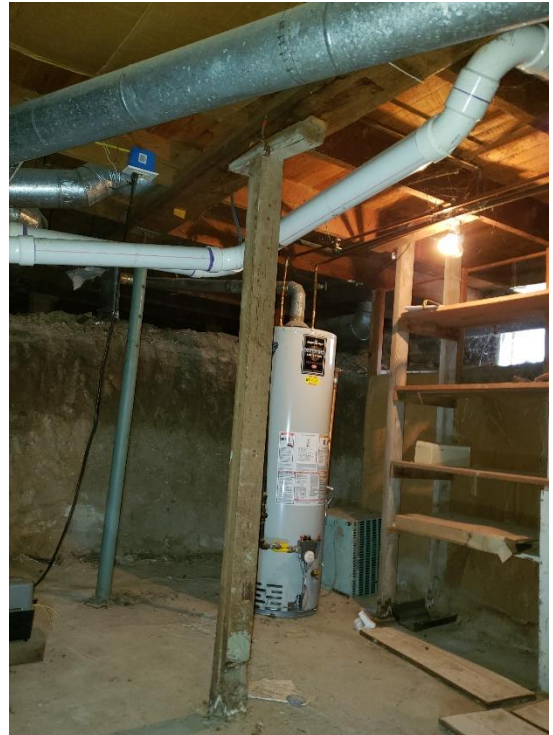
The poured concrete floor in the basement is in poor condition. Large cracks were observed and the extent, thickness, and reinforcement of the slab could not be determined without deconstructive investigation. Several columns that support the main floor and roof bear directly on the concrete slab and likely do not have any footings.

*Wood and steel columns bear on the concrete slab floor.*

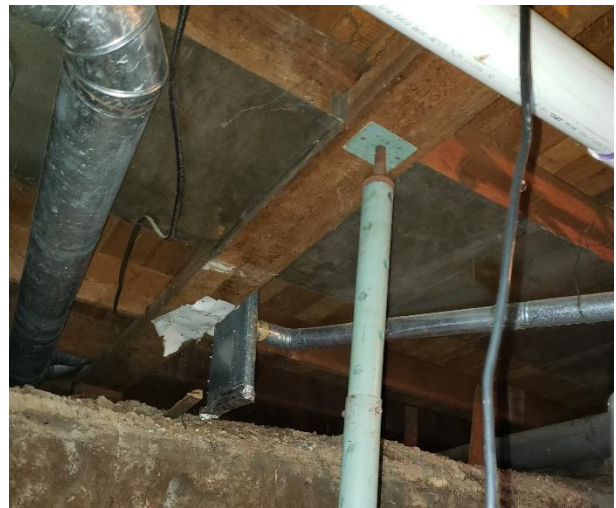
*Steel column supporting a flat wood beam.*

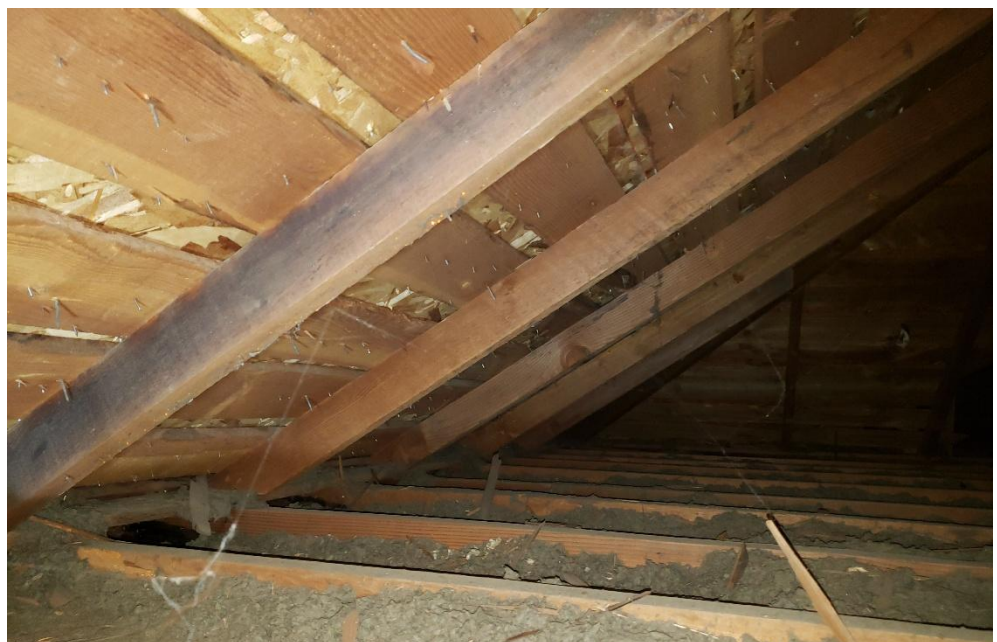
*1x skip sheathing with a layer of osb sheathing. Rafters bear on a 1x plate on top of the ceiling joists.*

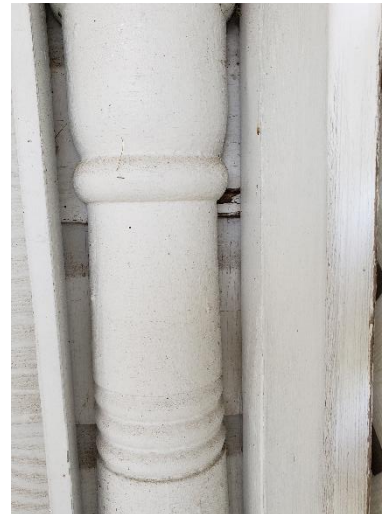
*Original wood shiplap siding behind metal siding and an attached column.*

Further investigation is required to determine all siding types beneath the steel siding. Investigative deconstruction is recommended in an inconspicuous area to determine if wood siding exists beneath the steel siding. If so, it is recommended that the current siding be removed from the entire house. There may also be additional layers of siding on top of the original wood siding that should be removed. If layers of stucco or composite siding exist, they should be tested for asbestos prior to removal. With the removal of siding layers, it is likely that original wood siding will be exposed throughout the entire house and various types of original wood siding may exist depending on the date of construction. Repair, refinish, or replace the original wood siding.

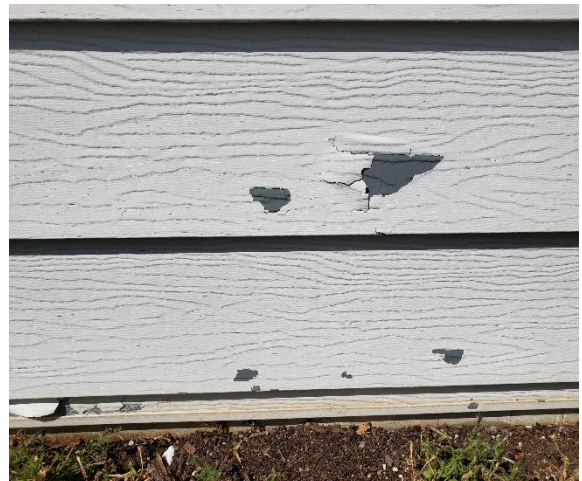
*Chipped paint finish common for metal siding.*

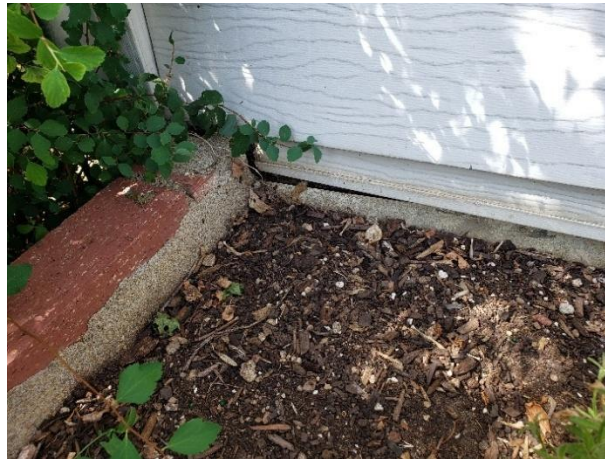
The brick planter box is in poor condition. There are cracks throughout the brick, and it could not be determined how the brick is supported or attached to the house. Additionally, it could not be determined if there is proper waterproofing where the planter box meets the house to prevent damage to the house walls and foundation. Nor could it be determined how the planter box is drained to remove water away from the house.

*Dirt in the planter box is adjacent to the house wall. A layer of sheet metal is seen possibly protecting the house from moisture.*

1. The brick planter box should be removed. The house siding, structural wood elements, and foundation at this location should be assessed by a licensed structural engineer after removal. It is possible that wood rot or foundation damage is present due to poor drainage.
2. Consider adding a faux brick chimney above the roofline that matches the chimney seen in the 1948 Boulder County Assessor's card image. The chimney location can be determined from the historic image as well as evidence of the original chimney in the attic and main floor walls. Additionally, there are several examples of similar chimneys found throughout Louisville.

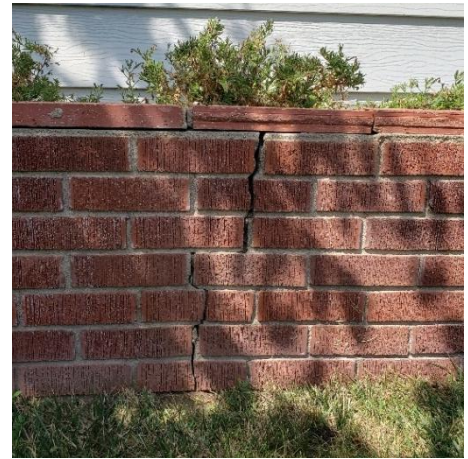
*A large crack running the full height of the brick planter box.*

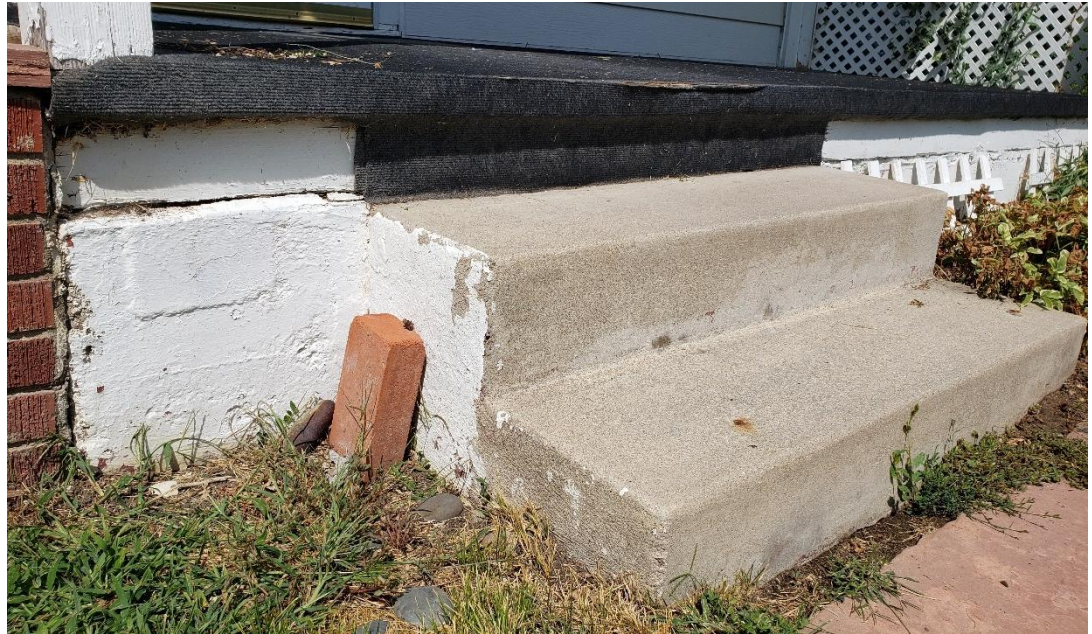
The carpet floor is well worn with several tears and is beyond the expected lifespan for such material. There is some water damage at the base of the wood columns, likely caused by prolonged water retention within the carpet and poor drainage of the deck surface.

*Concrete deck foundation, wood framing, and carpet over plywood with concrete steps.*

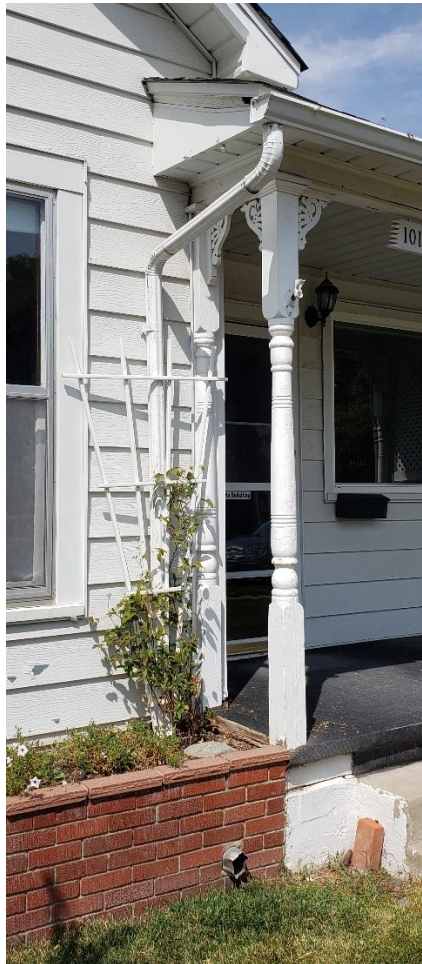
*Round downspout buried in brick planter.*

1. Ensure that all gutters, downspouts, and downspout extensions are maintained to discharge water away from the building foundation and are kept clear of debris.
2. The buried round downspout should be replaced as it is rusting and drains water near the front deck foundation.
3. The gutters and downspouts are not historic. Consider replacing the gutters with half-round gutters and the downspouts with round downspouts. Though not historic, these styles will more appropriately match the historic nature of the house.

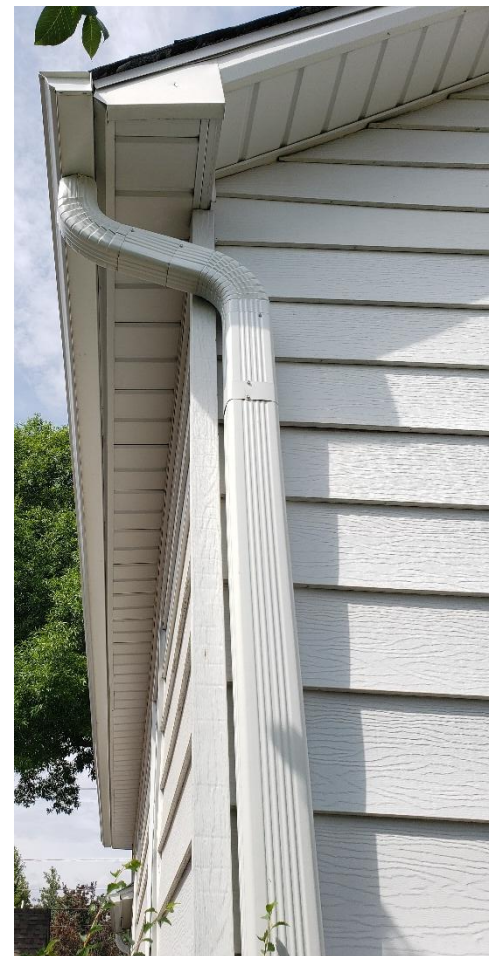
*V-groove soffit panels and metal wrapped fascia.*

The vinyl soffit and metal fascia should be removed throughout. Any original wood soffit and fascia beneath should be analyzed and the original sizes and locations should be determined. Scrape, repair, refinish, or replace all original wood roof elements.

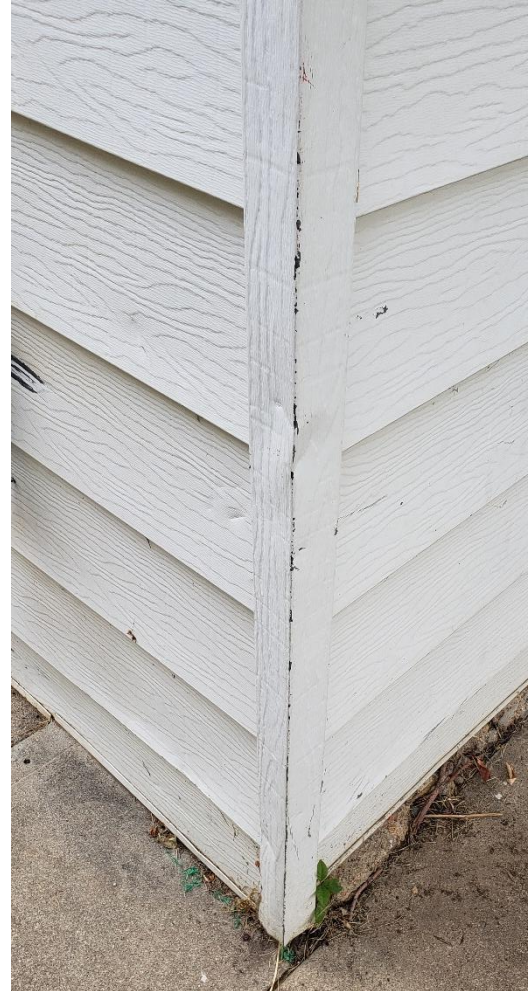
*Typical metal corner trim.*

The painted metal trim should be removed along with the steel siding. The original wood trim likely remains beneath the siding though some pieces may be missing. Determine the extent and condition of any remaining original wood trim. Missing pieces of original trim should also be determined, and the sizes and locations should be apparent in 'ghosting' on the original wood siding. Repair, replace, or restore all original painted wood trim elements.

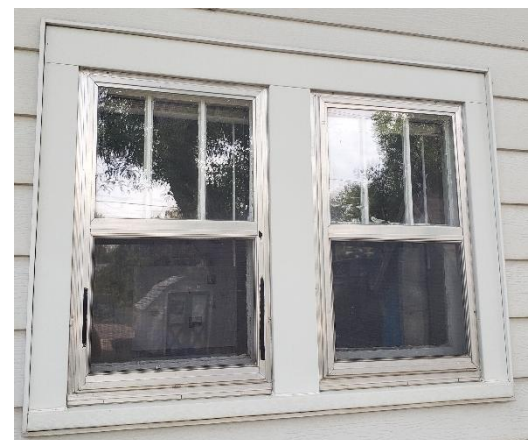
*Metal wrapped window trim & typical j-trim.*

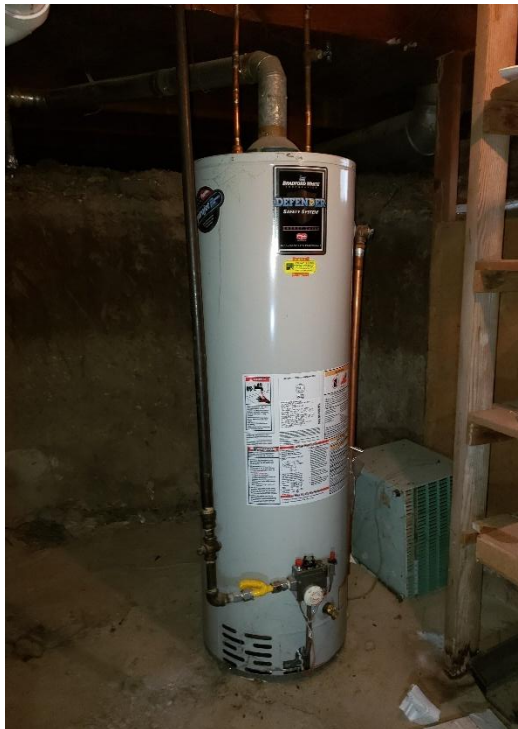
*40-gallon gas-fired water heater in the basement.*

Consider replacing the water heater with a high-efficiency unit with a sealed combustion intake/exhaust system.

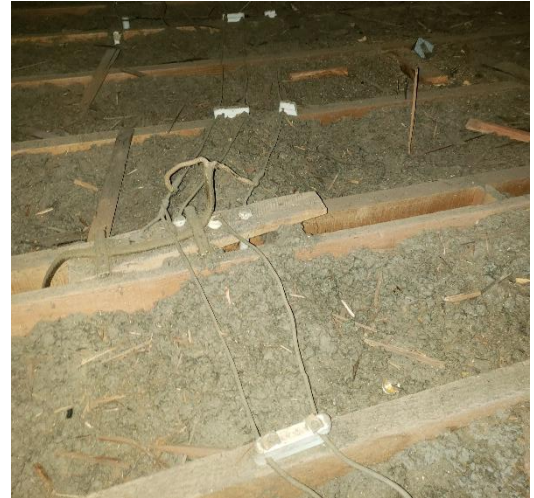
The electrical distribution was not fully tested during the site visit but appears to be in working condition. The presence of cloth-sheathed wiring could present a fire hazard and is therefore in poor condition. The full extent of wiring throughout the house could not be determined due to finish materials and therefore our analysis is limited.

*Cloth-sheathed wiring in the attic.*
