# HISTORIC STRUCTURAL ASSESSMENT

1013 LaFARGE AVENUE, LOUISVILLE, COLORADO

September 23, 2025

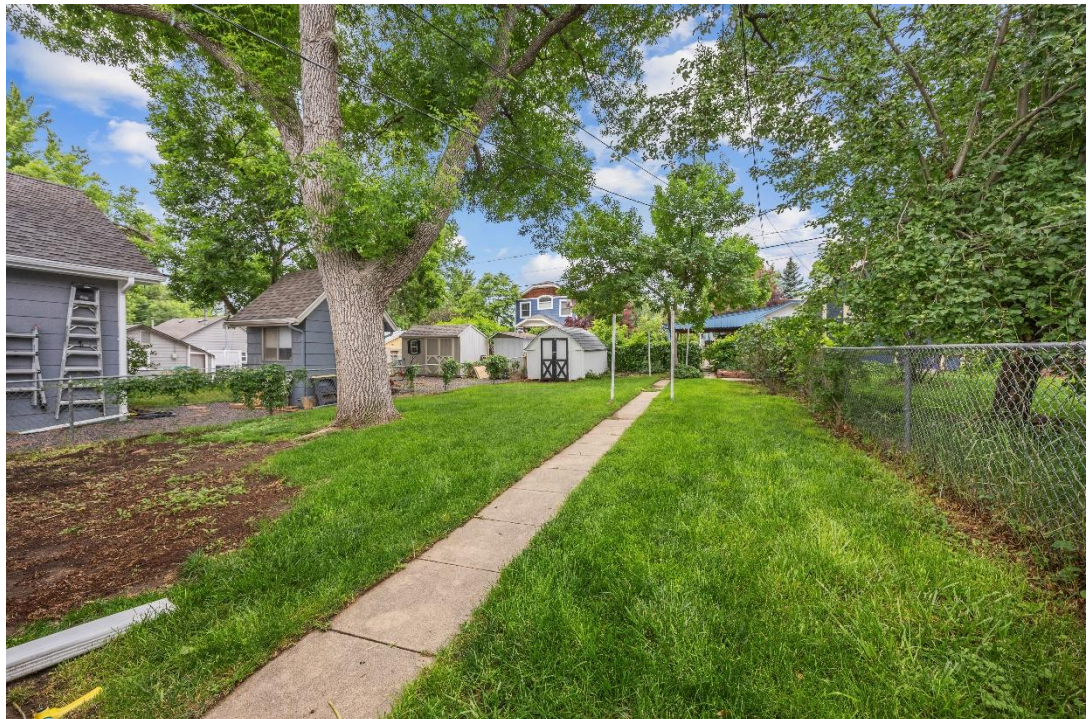
*Looking west from the northwest corner of the house.*

Overall, the landscape features are in good condition. The large trees appear to be well maintained and healthy. The small shrubs and vines along the property lines appear to be well managed and do not encroach upon the house. There is some smaller landscaping adjacent to the house foundation, but this is minimal, well established, and does not appear to pose a threat to the house structure.

1. Work with a licensed arborist to maintain the mature trees and shrubs. Ensure that growth does not interfere with the house roof, siding, or foundation.
2. Keep overgrowth trimmed away from the house and overhead electrical lines and remove any overhead branches to eliminate the risk of damage to the structure.

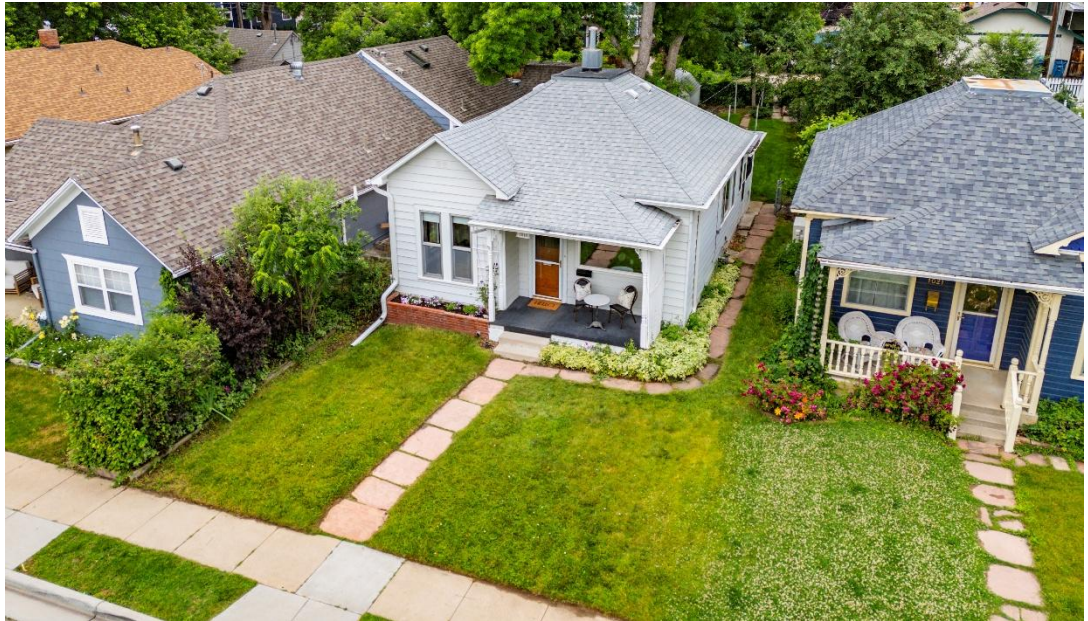
*Looking west from above LaFarge Avenue.*

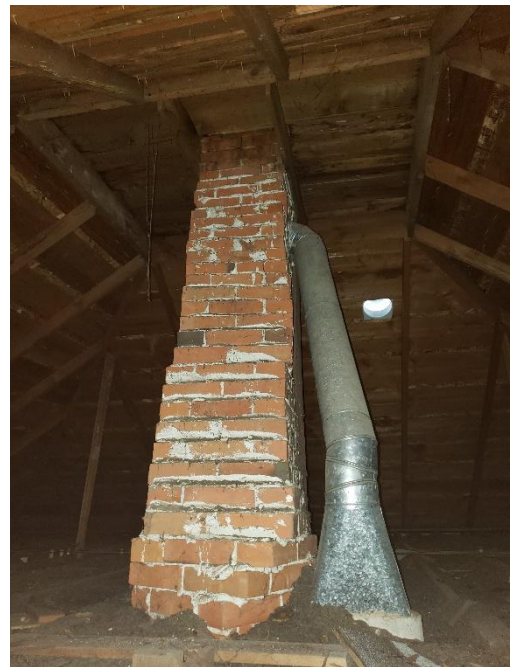
The roof is in fair condition and is constructed of typical materials and methods for houses built around the same time in the Louisville area. Several roof areas were minimally assessed due to limited access to observe the structural members. These roofs appear to be constructed using similar materials and techniques as those areas observed and appear to be performing adequately. The uppermost flat roof of the original house is in poor condition. This area is not properly supported and does not appear to have a minimum slope for drainage.

The attic insulation is in poor condition as it appears to be providing a minimal insulation R-value that does not meet current code standards.

*Hipped roof framing with a central brick chimney.*

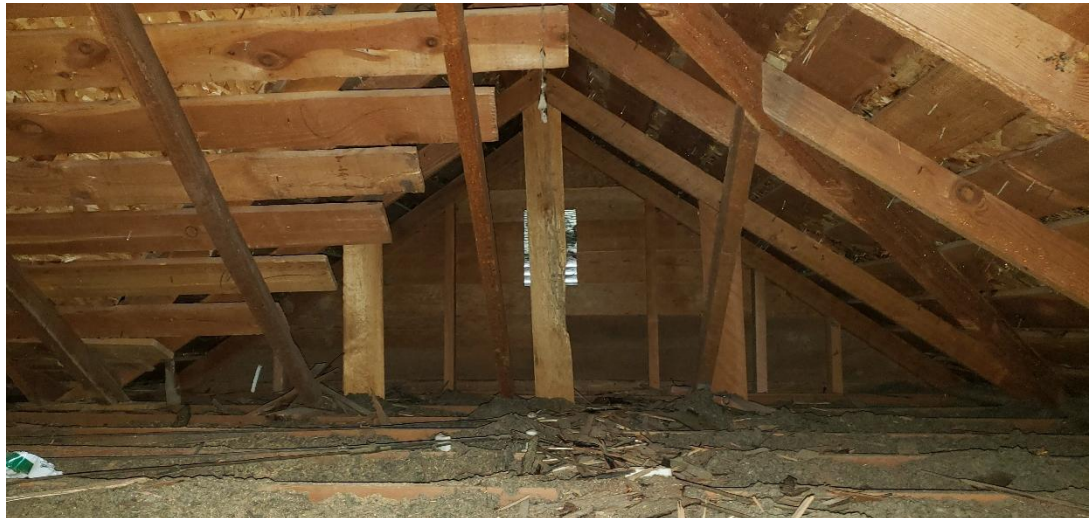
*Gable end wall seen in the attic.*

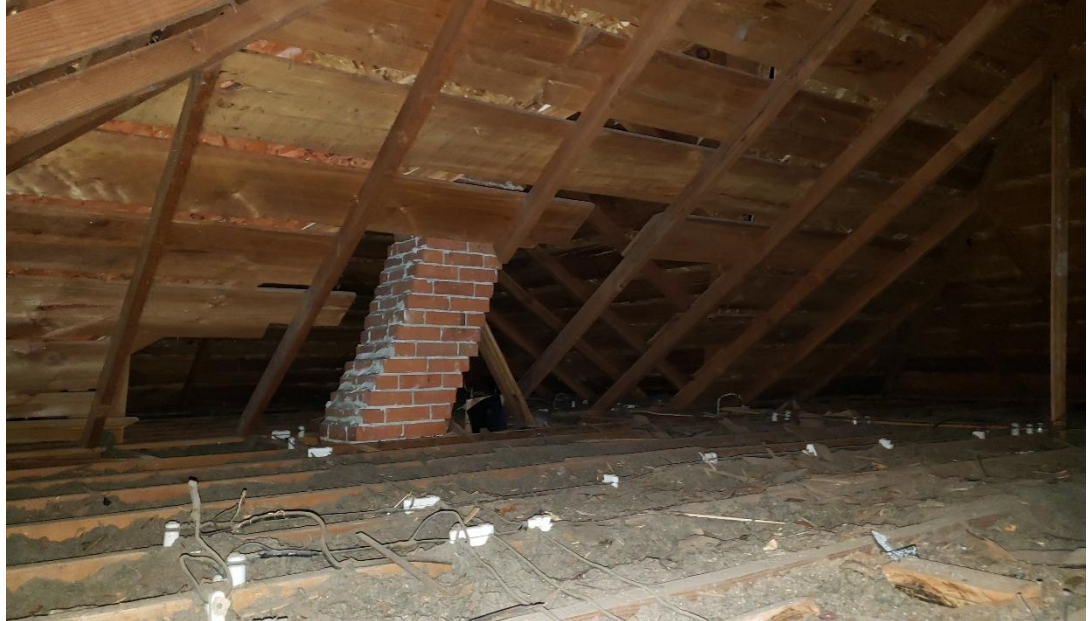
*Remnants of a brick chimney above the kitchen seen in the attic.*

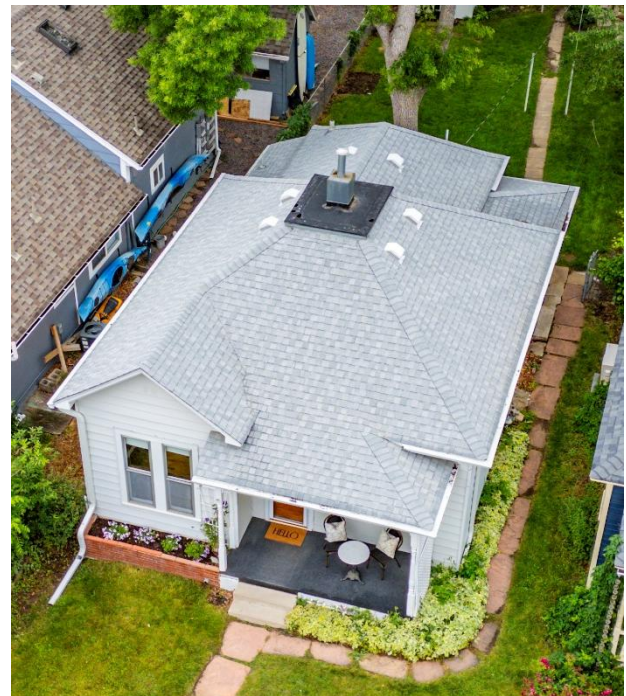
The condition of metal flashing, if any is present, is indeterminable at this time.

*Asphalt roofing on the entire house with mushroom style vents.*

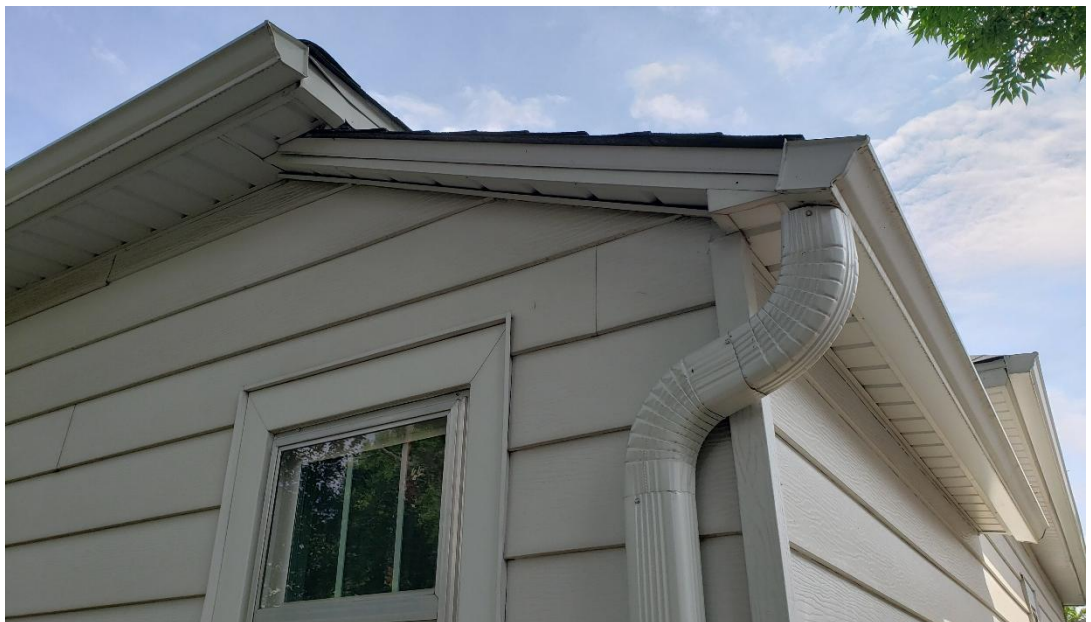
Painted white, k-style gutters are found throughout the house. Gutters are located at the end of all roof eaves in appropriate locations and of appropriate lengths for adequate water collection. Some of the gutters have metal standoffs while other locations do not.

Painted 2x3 downspouts are located throughout and appear to be an adequate amount for proper drainage where located. There is a round downspout that drains the covered front deck roof. This downspout is buried in the brick planter box and daylights at the base of the brick wall. It appears that the 2x3 downspouts were added sometime after 2012 and replaced round downspouts in the same locations. Downspouts have downspout extensions at most locations.

*Painted k-style gutters and 2x3 downspouts are located throughout.*

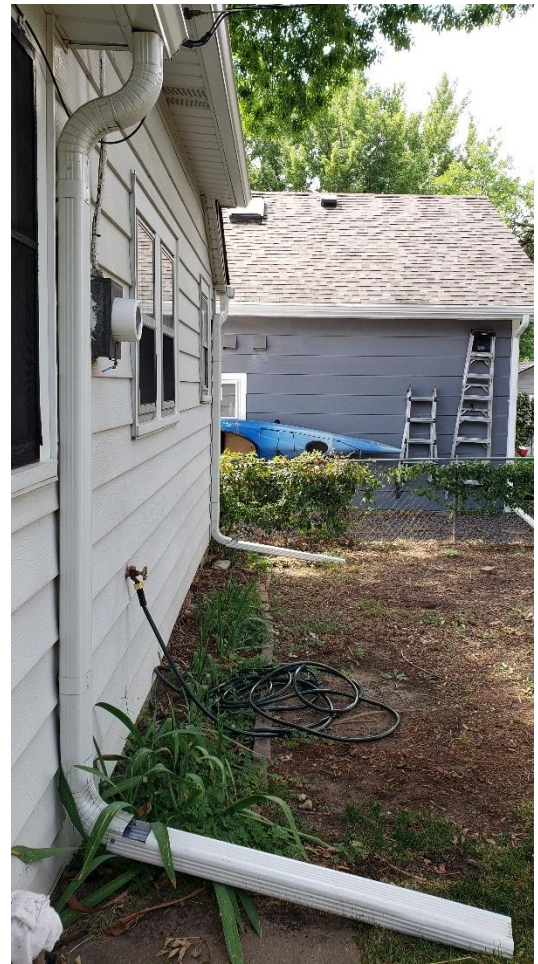
*Downspouts with extensions.*

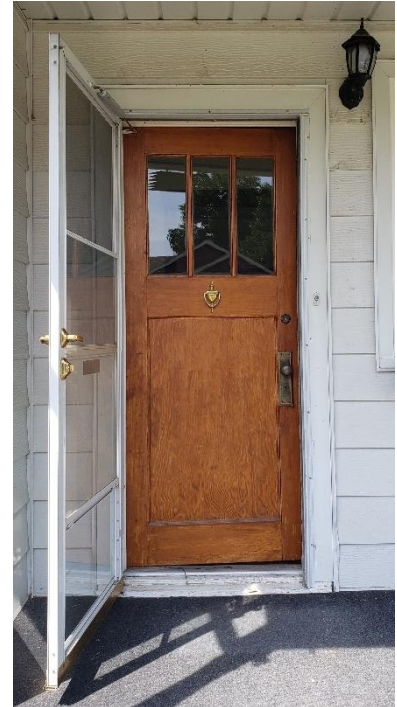
*Wood front door and storm door.*

Both doors should be replaced with painted or stained wood doors. The door style from 1948 cannot be determined. However, there are numerous examples of historic wood doors from the same timeframe throughout the Louisville area including the front door on the house located at 1021 LaFarge. The interior door between the kitchen and mudroom is also an example of a door that was previously an exterior door on this house. Work with a licensed architect and the historic preservation committee to select an appropriate front door style that matches the period of significance. The north door should also be replaced with an appropriate style for the period of significance but does not need to match the style chosen for the front door.

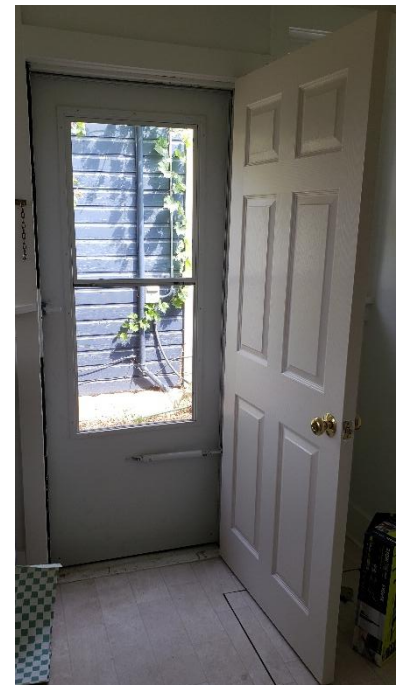
*North side door and storm door.*

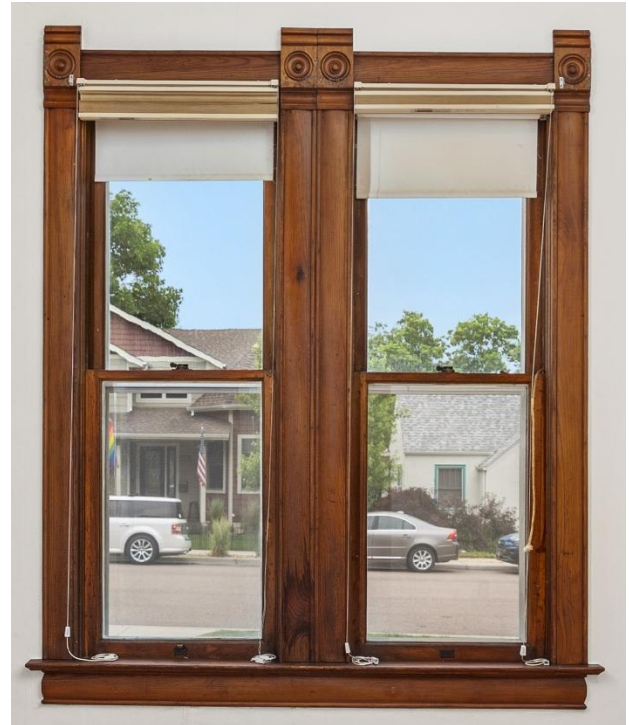
The original windows are tall and narrow single-hung wood windows with counterweights. These windows are found on the original house. The original windows would have all been the same size with paired windows in the east facing gable. The east facing window under the covered front deck was replaced with an aluminum window with double-pane glass. The replacement window modified the original window opening at this location and is wider and not as tall as the original window. The original windows on the north side of the house were also removed. One of these windows was not replaced and the opening was framed in. Two windows were replaced with a larger opening consisting of two wood single-hung windows with a center picture window.

*Original wood windows with counterweights.*

3. The original wood windows should be fully restored. New components will likely need to be used, and current energy code should be followed. Ensure that all restored windows are fully operable and match the original window style and operation. Alternatively, the original windows could be replaced with new aluminum clad wood or fiberglass windows. New windows should match the existing size, operation, and locations of all original windows. This recommendation is for a total of eleven windows.

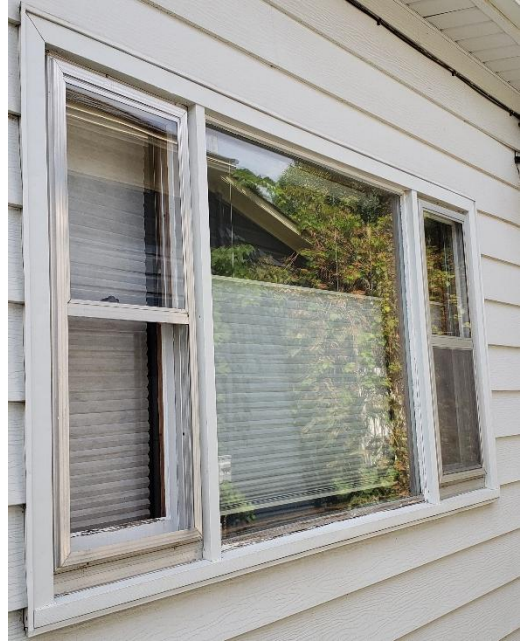
*Replacement windows and aluminum storm windows.*

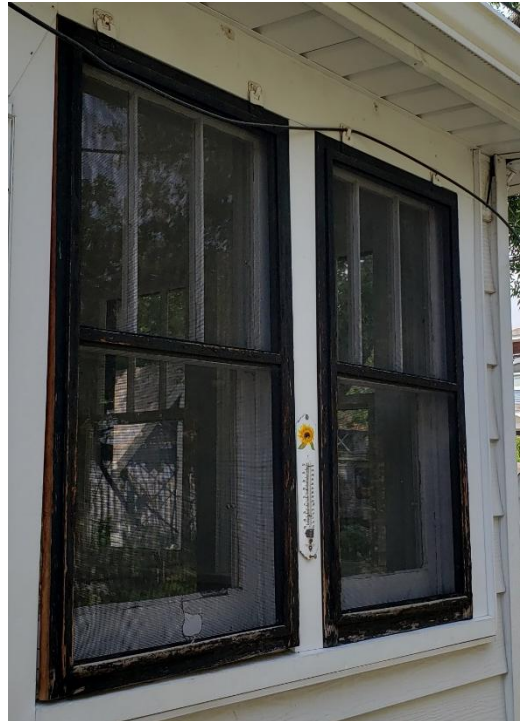
*Wood framed screens on mudroom windows.*

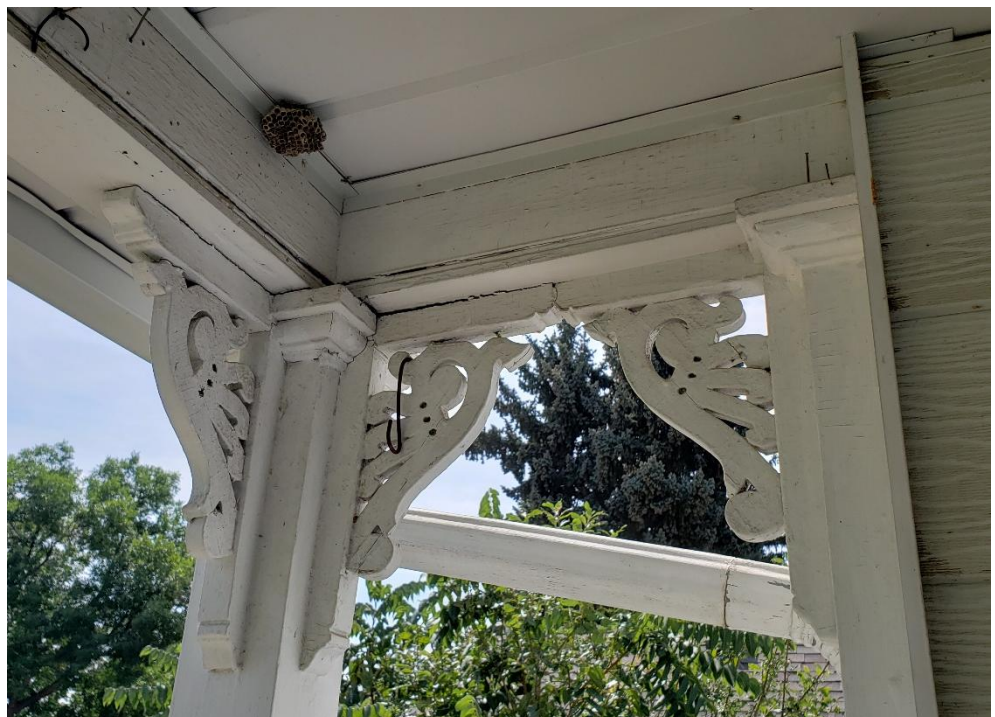
The decorative brackets on the front deck are in poor condition. One of the brackets is nearly entirely missing and several of the other brackets are broken.

*Decorative painted wood brackets.*

1. The decorative brackets should be replaced with new brackets that match the current profile.
2. Further investigation into other decorative elements such as shingle siding should be done after the removal of the steel siding. Such decorative elements may still be present and will require further analysis, or there may be 'ghosting' of elements that were removed and further research into these items will be required.

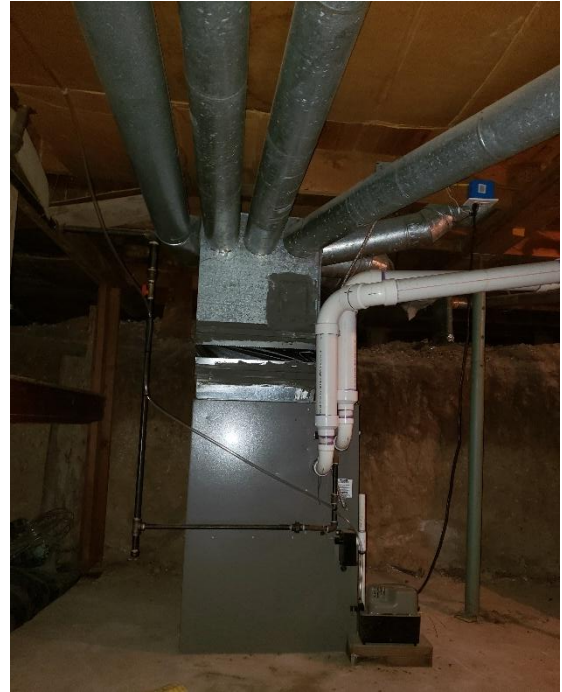
The heating system appears to be in good condition but was not tested during the site visit. There is no record of when the furnace was installed, but it looks like it is no more than 20 years old.

*Gas furnace that sits on the concrete basement floor.*

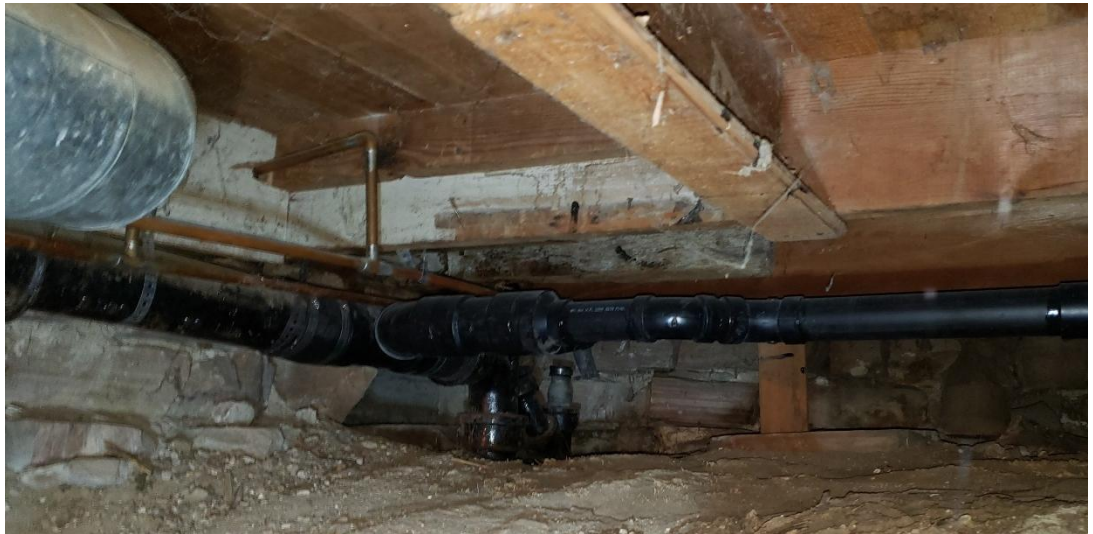
The water heater, supply and waste lines, and sewer appear to be in good condition, but were not tested.

*Copper supply lines and abs plastic waste lines to the main cast iron waste line in the basement.*

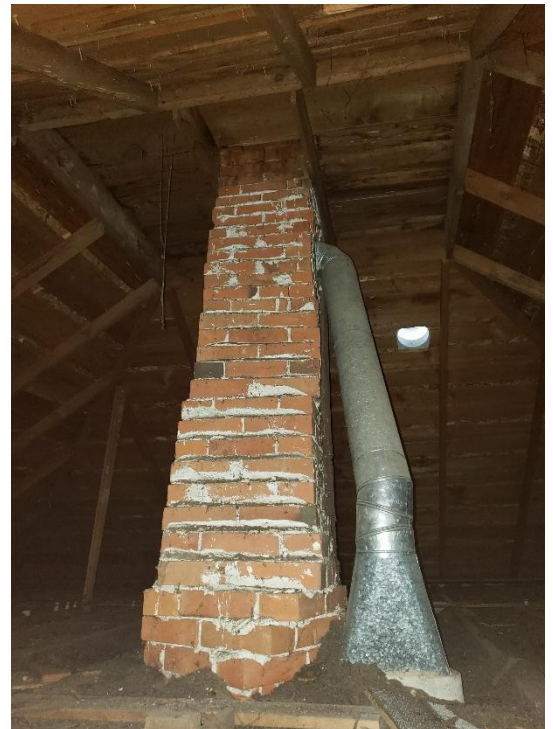
*The water heater vent enters the chimney in the attic.*

Consider replacing the water heater with a high-efficiency unit with a sealed combustion intake/exhaust system.

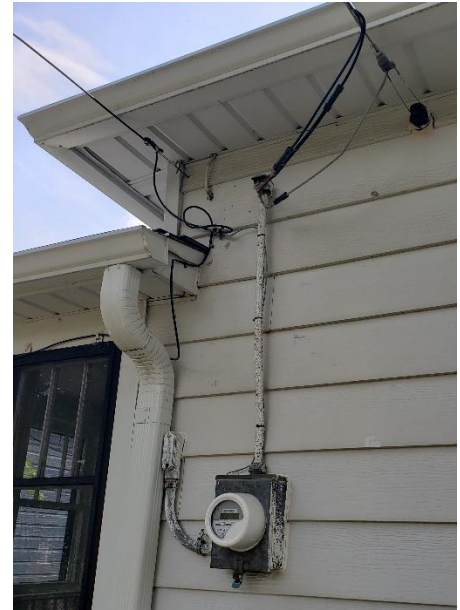
The electrical service was not tested during the site visit but appears to be in working condition. The panel appears to be sized appropriately for the existing house requirements but will likely need to be upgraded for any future improvements. The electrical panel is also an older model that likely does not meet current code standards and is beyond the expected lifespan.

*Electrical meter on the west side of the house.*

1. The electrical service panel should be replaced by a licensed electrical engineer with a new 200-amp panel compliant with current codes.
2. Consider replacing the overhead electrical service with a new underground electrical line compliant with current codes and replaced by a licensed electrical engineer.

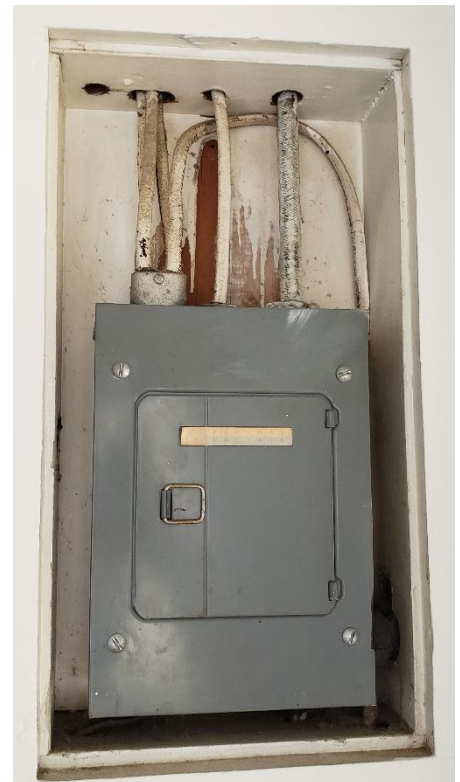
*Electrical panel in the mudroom.*

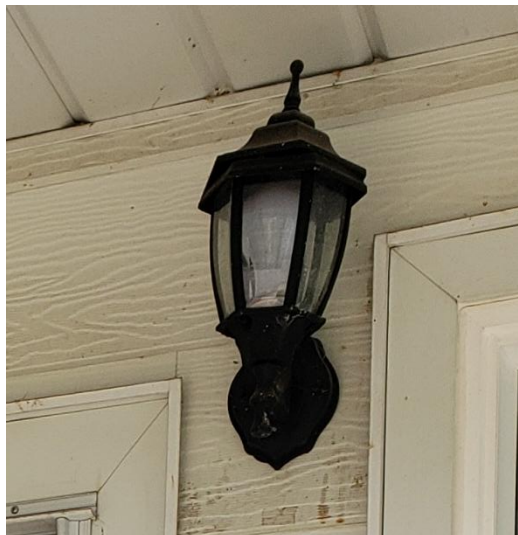
The light fixtures were not tested but appear to be in working condition. Neither of the exterior light fixtures are historic but the light near the front door may be in a historic location.

*Sconce light at the front door.*

1. Consider installing new exterior lighting that complies with Dark Sky regulations.
2. Removal of siding may reveal original light fixture locations apparent in the original wood siding. If the siding is removed and historic light fixture locations are determined, replace the exterior light fixtures with full cutoff, high-efficiency units.

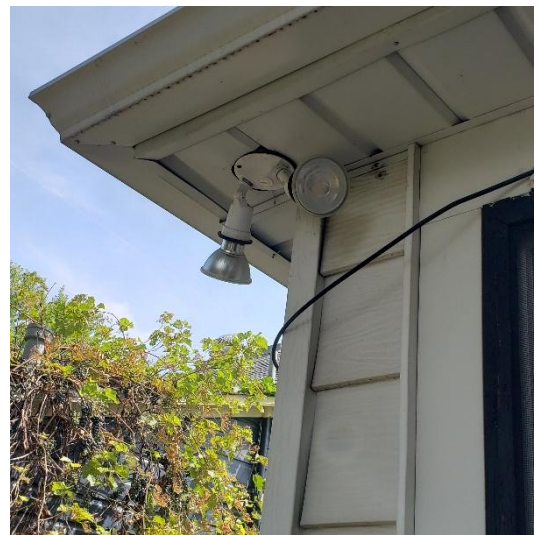
*Flood light in the northwest house corner.*
