# Historic Preservation Commission

## Agenda

A request to find probable cause to allow for funding of a historic structure assessment for 1132 La Farge Avenue.

Requests for Landmark Designation, Alteration Certificate and Preservation and  
Restoration Grant

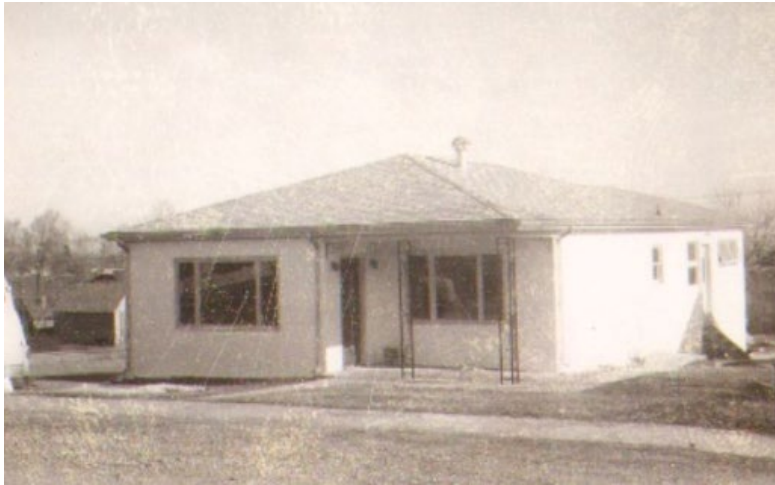
In 1956, the Madonna family completely remodeled their house to the current configuration and layout. It was reappraised in 1977 and two photos of the house are shown below.

1956 Boulder County assessor photo and floor plan.

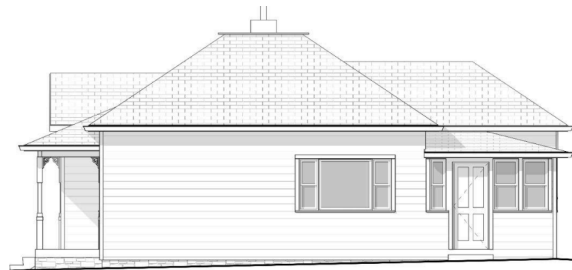
EXISTING NORTH ELEVATION

Previously, there were also three windows on the north side of the house that all appear to match the size and style of the remaining historic windows. These windows were removed at an unknown time and there is currently a single large window opening in approximately the same location as two of the original windows. Our alteration proposal is to restore all three of the north side historic window locations. However, the original windows were tall windows with low sill heights. Low sill heights make use of space difficult in modern houses, and there are privacy concerns given the close proximity of the neighboring house to the north. Therefore, while we propose restoring the historic window locations, we are also proposing to reduce the size of all three windows to be equal to half the size of the original single-hung windows.

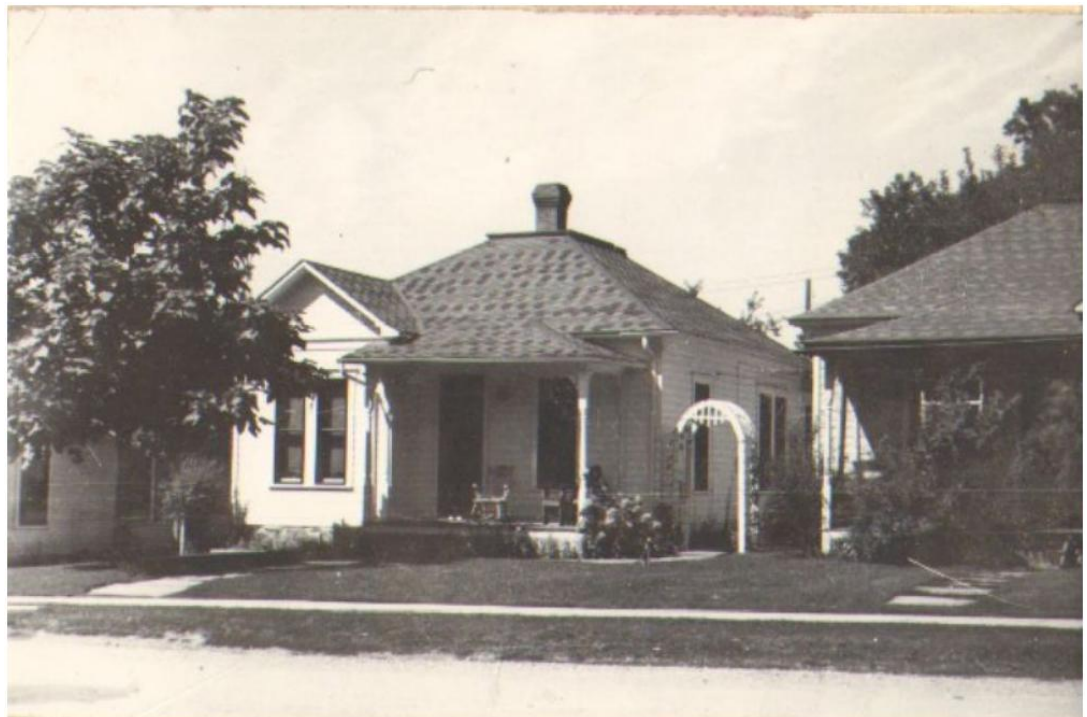
*1948 Boulder County Assessor Card photo and floorplan for 1013 La Farge.*

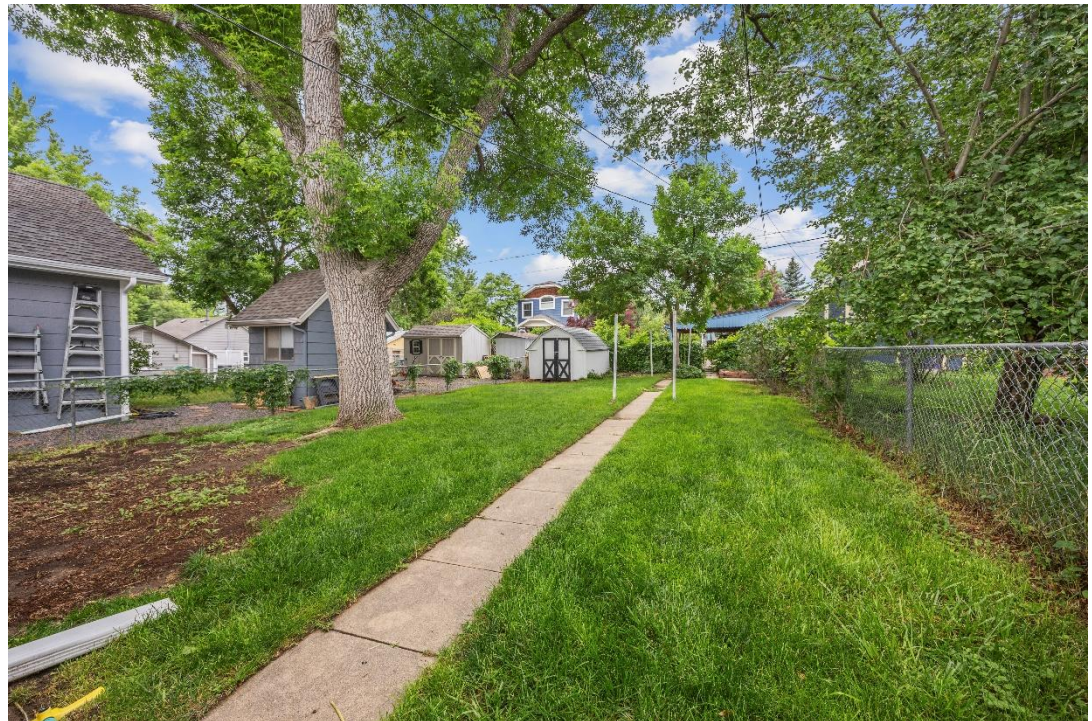
*Looking west from the northwest corner of the house.*

Approximately one quarter of the lot is covered by the footprints of the house and a shed in the southwest property corner. The house sits in the eastern half of the lot, approximately 25 feet from the east property line. There is a sandstone paver walkway from the public sidewalk at LaFarge Avenue. The sandstone walkway also leads around the north side of the house to a mudroom entrance in the northwest corner of the house. There is also a concrete walkway from the west side of the house to the alley.

Most of the site is grass with some areas of wood mulch. There is a large maple tree central on the property and another mature tree at the west end of the property. There are shrubs along the north property line and vines growing along the chain-link fences throughout. Additionally, there are small ground-cover plantings adjacent to the house at the northeast corner.

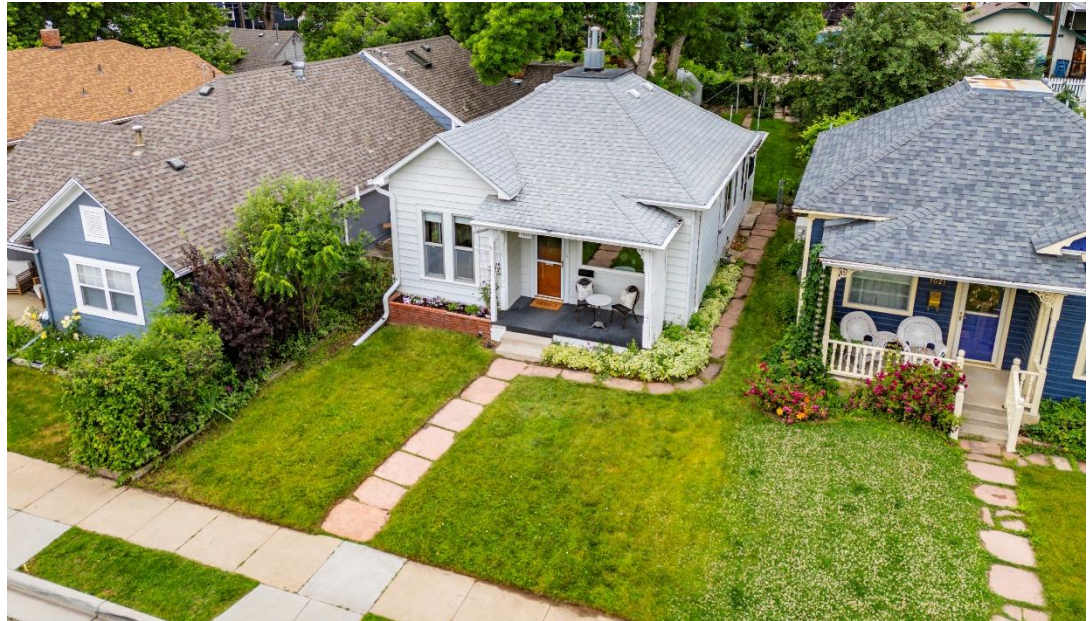
*Looking west from above LaFarge Avenue.*

Overall, the landscape features are in good condition. The large trees appear to be well maintained and healthy. The small shrubs and vines along the property lines appear to be well managed and do not encroach upon the house. There is some smaller landscaping adjacent to the house foundation, but this is minimal, well established, and does not appear to pose a threat to the house structure.

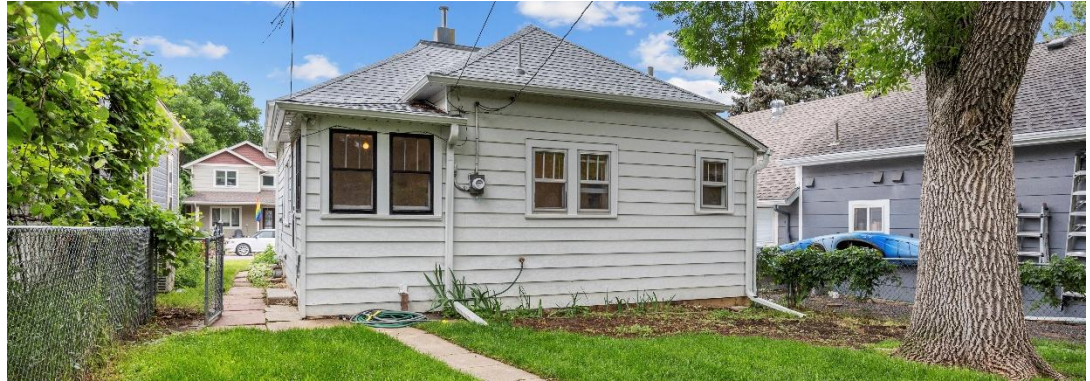
*Grade is highest at the northwest corner of the house where finish materials are in contact with grade.*

Overall, the site is relatively flat with a slight downward slope to the east. Grading around the house appears to drain away from the foundation, though minimally in most areas. Grading around the house is also highest at the northwest corner where finish materials meet grade and lowest in the southeast corner. There are landscaping features including pavers, ground covers, and a brick planter that make it difficult to determine the height of the foundation relative to grade along the north and east sides of the house. The foundation is exposed in the southwest corner and along the length of the south wall. The top of the foundation on the south side sits a minimum of four inches above grade.

The overall site grading is in poor condition. It is important that the grading around the house should be a minimum of six inches below the top of the foundation and slope away from the foundation for at least the first five feet. Due to the nature of the lot, it is difficult to meet these requirements without a large amount of regrading or lifting the building and pouring a new foundation.

The effects of poor grading are difficult to determine in one site visit, and some areas require deconstructive investigation. Landscaping and siding would need to be partially removed to determine the height of the foundation relative to grade in some areas along the west, north, and east sides of the house. Evidence of water infiltration into the crawlspace and basement was not observed. However, not all areas are visible and therefore structural damage may be present in the non-visible areas and require further investigation.

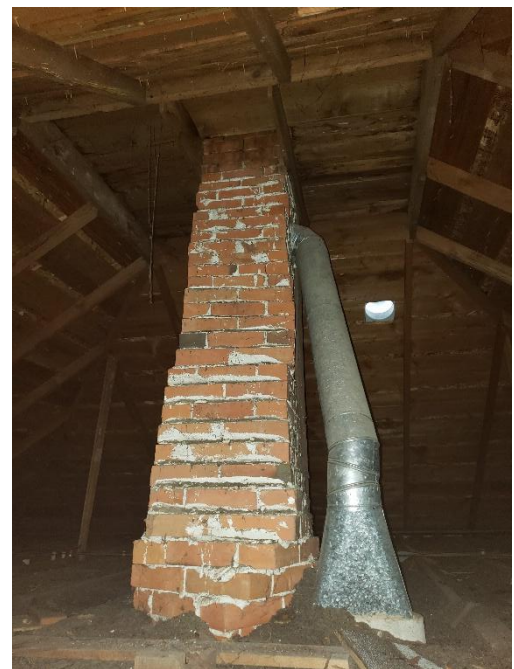
*Hipped roof framing with a central brick chimney.*

The roof is in fair condition and is constructed of typical materials and methods for houses built around the same time in the Louisville area. Several roof areas were minimally assessed due to limited access to observe the structural members. These roofs appear to be constructed using similar materials and techniques as those areas observed and appear to be performing adequately. The uppermost flat roof of the original house is in poor condition. This area is not properly supported and does not appear to have a minimum slope for drainage.

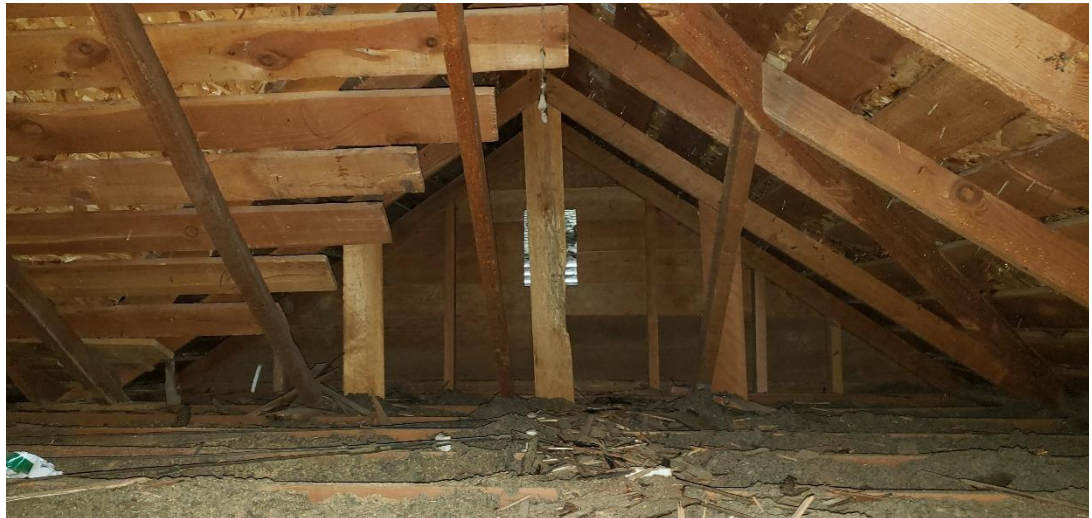
*Gable end wall seen in the attic.*

The main level wall framing was not exposed for review. The wall framing is likely a 2x4 stud wall with studs on regular spacing (site measurements support this assumed wall thickness). The original wood siding appears to be attached directly to the wall framing, as seen in the attic and it is noted on the 1948 Boulder County Assessor's card that there is no wall sheathing. The wall insulation type could not be determined, if any exists. It is likely that there is minimal to no insulation in the original house walls.

It appears that several of the interior framed walls are load bearing for the roof above and that they are supported by beams and walls in the basement as described above. Further analysis of these walls should be completed prior to their removal or modification.

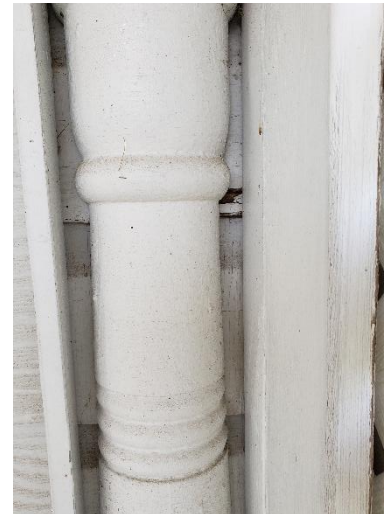
*Original wood shiplap siding behind metal siding and an attached column.*

Steel siding was commonly applied on top of existing siding, oftentimes with a layer of half-inch foam beneath. Layers of siding beneath the current steel siding could not be determined without deconstructive investigation. It is likely that the original wood siding still exists throughout the house. There also might be different types of wood siding used on the additions than that used on the original house. The 1948 Boulder County Assessor's card indicates that the siding at that time was 'woodboard'. The original siding was likely painted wood shiplap siding with a Dutch-cove profile. There is one area on the covered front deck where there is an attached column and there is a gap between the attached column and the steel siding. Small sections of Dutch-cove wood shiplap siding can be seen at this location. Additionally, it is possible that sometime around the middle of the 20th century, a layer of stucco siding was added on top of the original wood siding. This has been found to be the case for several houses throughout Louisville but there is no evidence of this at 1013 LaFarge at this time.

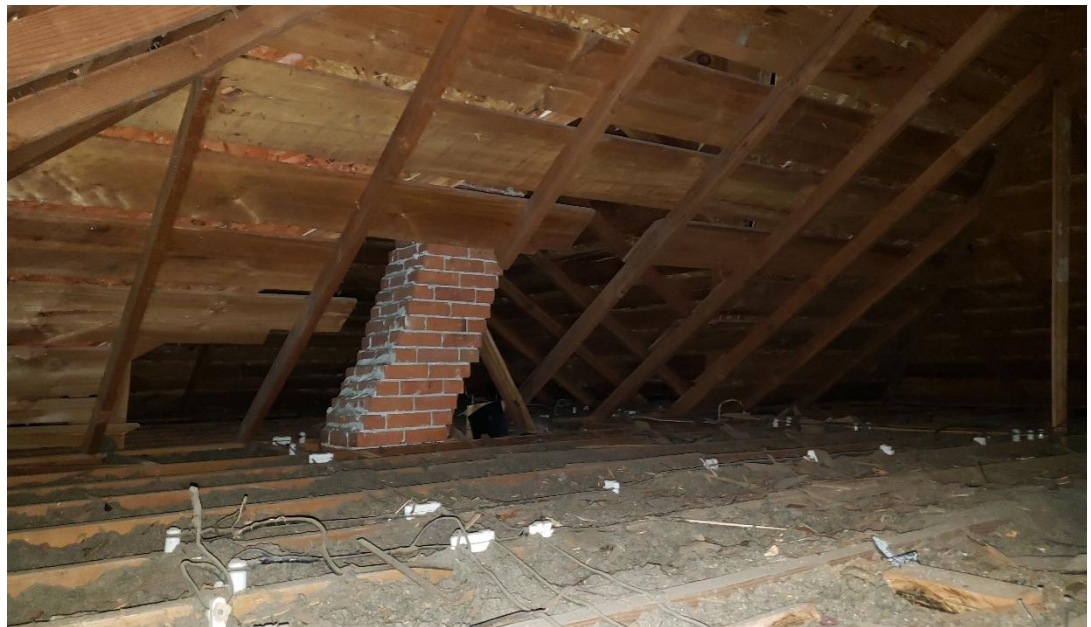
*Remnants of a brick chimney above the kitchen seen in the attic.*

1. The brick planter box should be removed. The house siding, structural wood elements, and foundation at this location should be assessed by a licensed structural engineer after removal. It is possible that wood rot or foundation damage is present due to poor drainage.
2. Consider adding a faux brick chimney above the roofline that matches the chimney seen in the 1948 Boulder County Assessor's card image. The chimney location can be determined from the historic image as well as evidence of the original chimney in the attic and main floor walls. Additionally, there are several examples of similar chimneys found throughout Louisville.

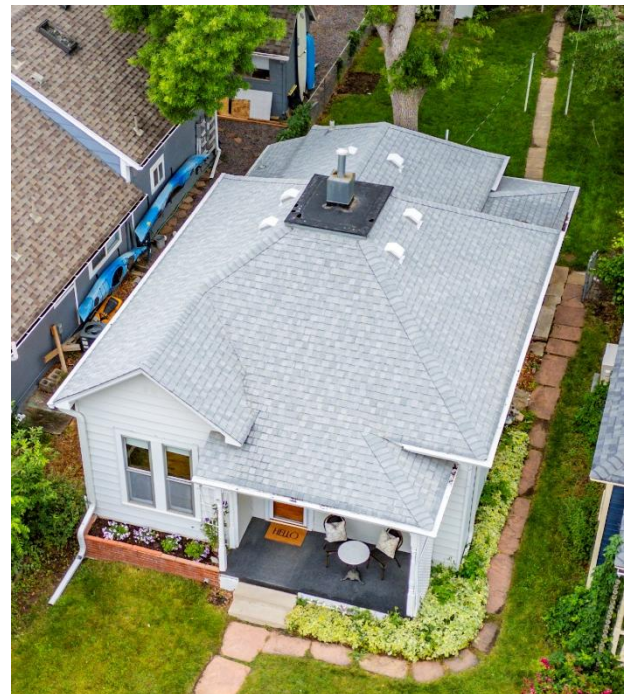
*Asphalt roofing on the entire house with mushroom style vents.*

The house roof is covered with an asphalt composite shingle roof. Building records show that in 2003 roofing layers were removed and a new asphalt composite shingle roof was installed. The current asphalt shingle roof was installed in 2018, likely replaced due to hail damage as was common throughout Louisville at that time. The 1948 Boulder County Assessor's card indicates that the roof at that time was asphalt, and the original roof was likely wood shingles.

The asphalt composition shingle roof is in good condition and still within the expected lifespan of such a roof. The roof venting does not appear to be adequate for the amount of attic space and lacks low roof venting.

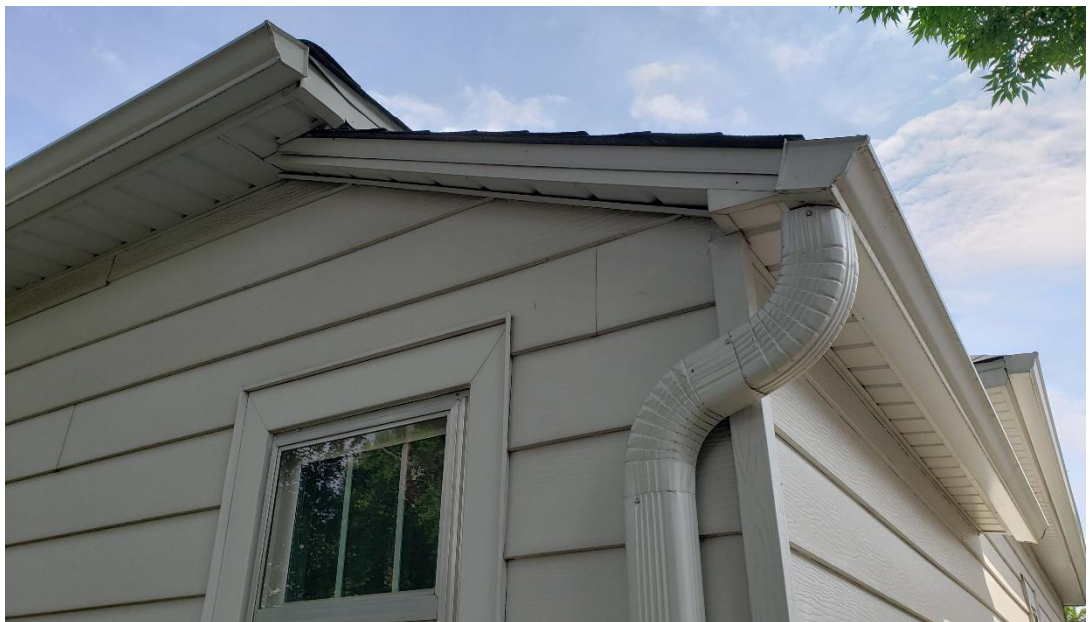
*Painted k-style gutters and 2x3 downspouts are located throughout.*

Painted white, k-style gutters are found throughout the house. Gutters are located at the end of all roof eaves in appropriate locations and of appropriate lengths for adequate water collection. Some of the gutters have metal standoffs while other locations do not.

Painted 2x3 downspouts are located throughout and appear to be an adequate amount for proper drainage where located. There is a round downspout that drains the covered front deck roof. This downspout is buried in the brick planter box and daylights at the base of the brick wall. It appears that the 2x3 downspouts were added sometime after 2012 and replaced round downspouts in the same locations. Downspouts have downspout extensions at most locations.

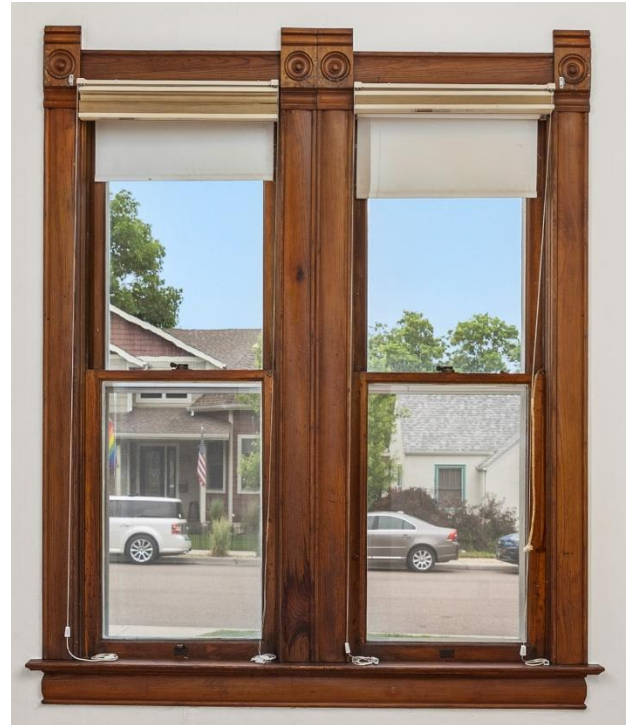
*Original wood windows with counterweights.*

The original windows are tall and narrow single-hung wood windows with counterweights. These windows are found on the original house. The original windows would have all been the same size with paired windows in the east facing gable. The east facing window under the covered front deck was replaced with an aluminum window with double-pane glass. The replacement window modified the original window opening at this location and is wider and not as tall as the original window. The original windows on the north side of the house were also removed. One of these windows was not replaced and the opening was framed in. Two windows were replaced with a larger opening consisting of two wood single-hung windows with a center picture window.

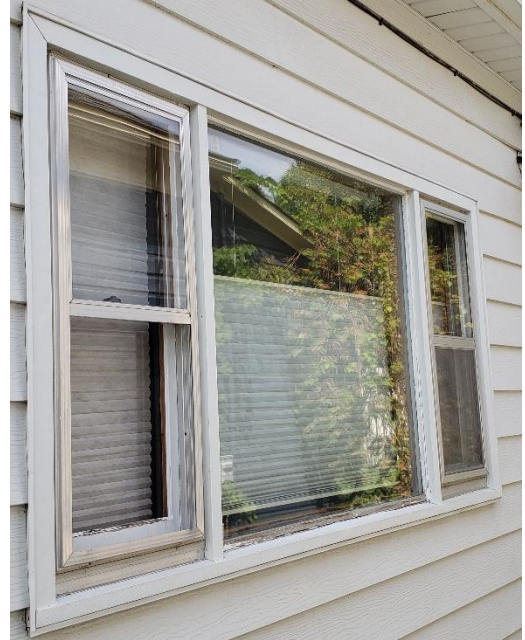
*Replacement windows and aluminum storm windows.*

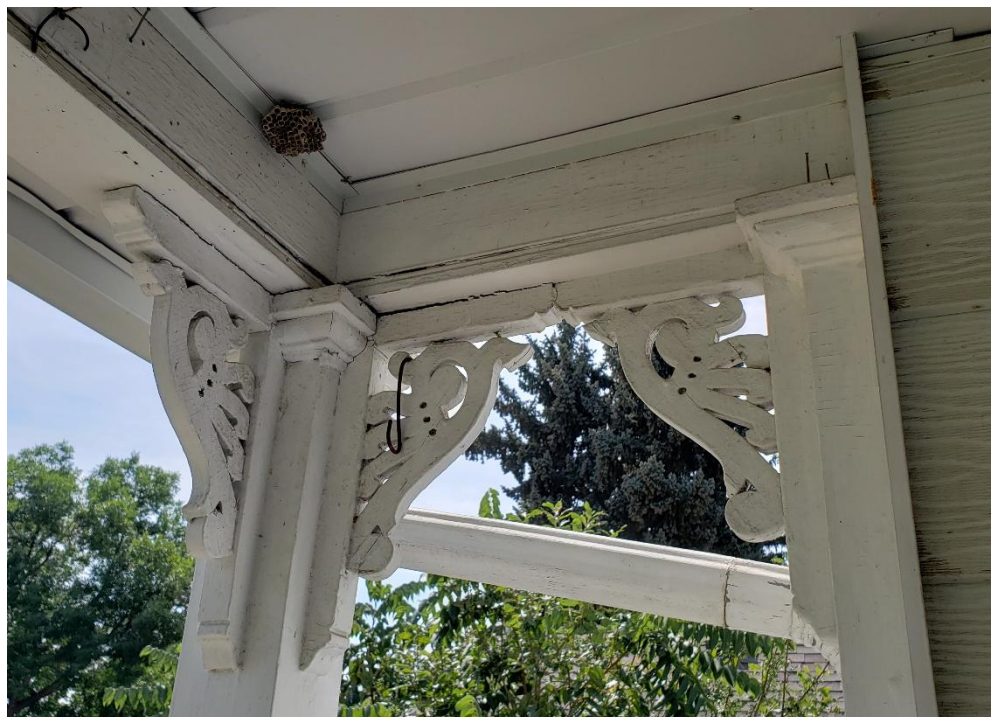
*Decorative painted wood brackets.*

1. The decorative brackets should be replaced with new brackets that match the current profile.
2. Further investigation into other decorative elements such as shingle siding should be done after the removal of the steel siding. Such decorative elements may still be present and will require further analysis, or there may be 'ghosting' of elements that were removed and further research into these items will be required.

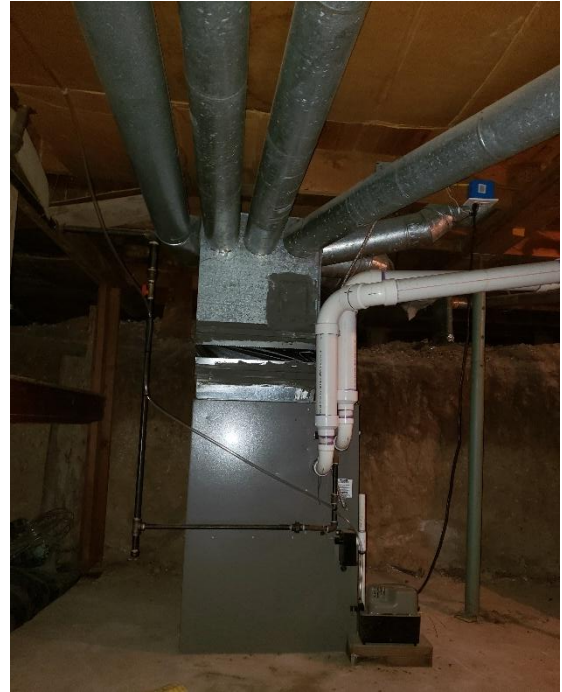
*Gas furnace that sits on the concrete basement floor.*

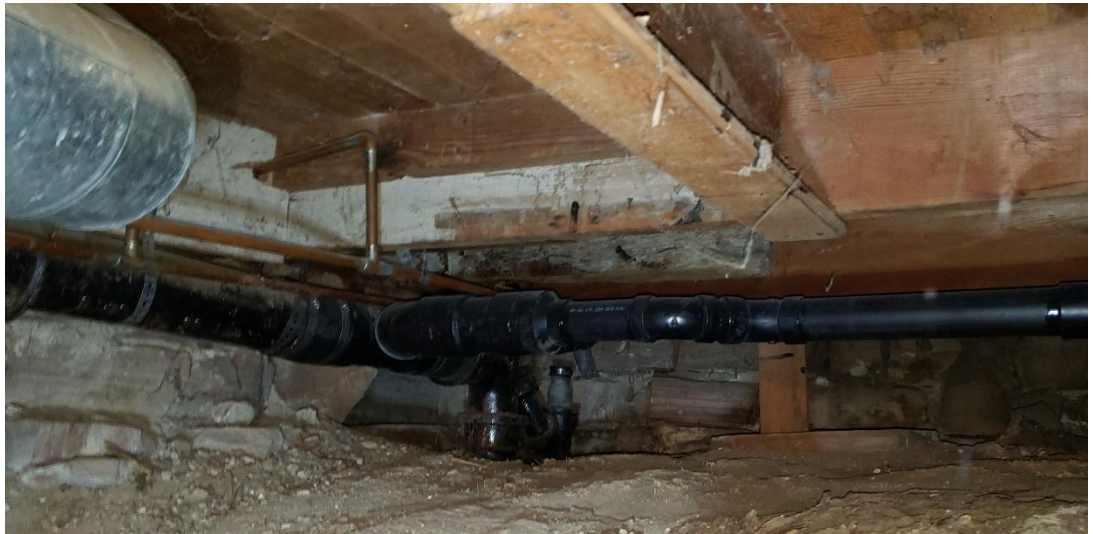
*Copper supply lines and abs plastic waste lines to the main cast iron waste line in the basement.*

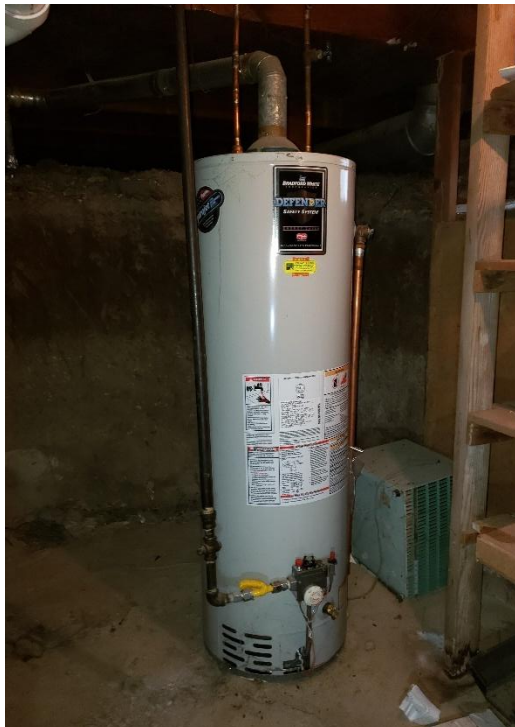
*40-gallon gas-fired water heater in the basement.*

Consider replacing the water heater with a high-efficiency unit with a sealed combustion intake/exhaust system.

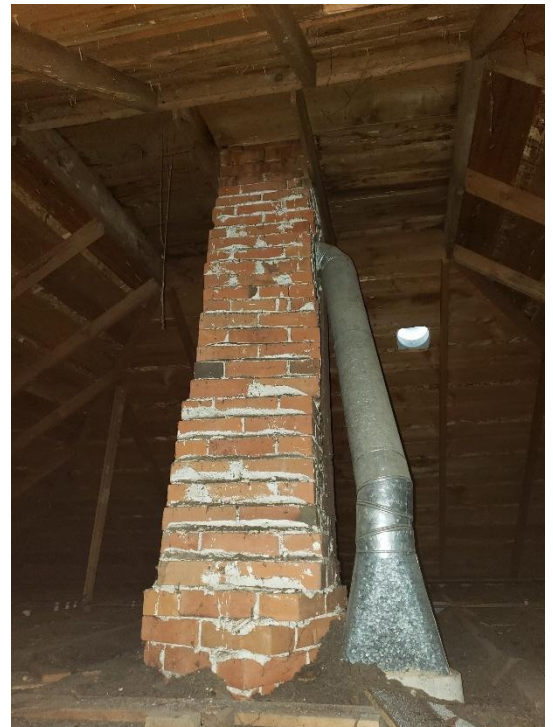
*The water heater vent enters the chimney in the attic.*

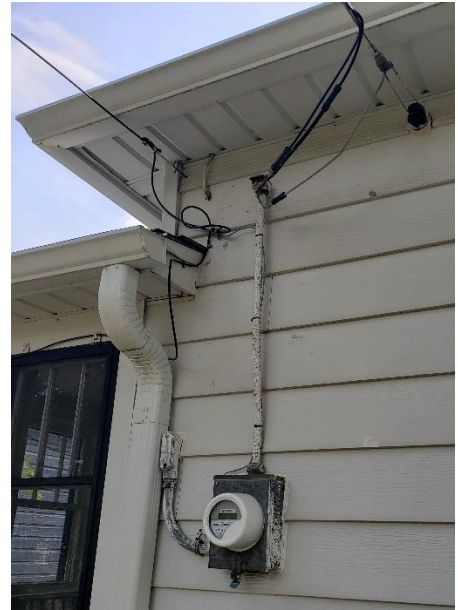
*Electrical meter on the west side of the house.*

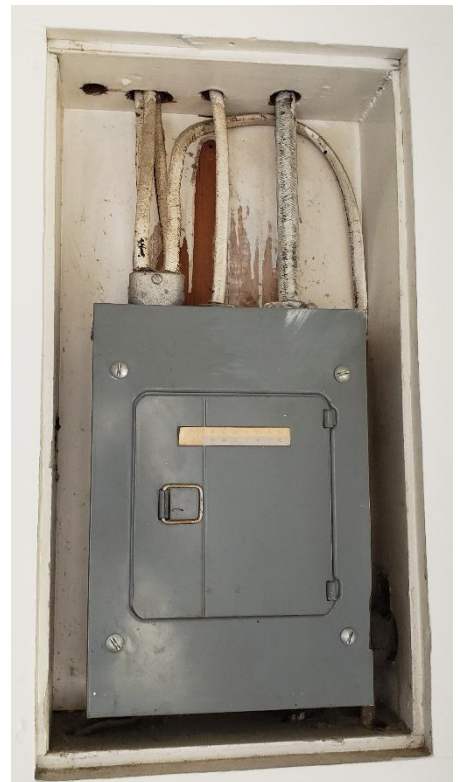
*Electrical panel in the mudroom.*

The electrical distribution was not fully tested during the site visit but appears to be in working condition. The presence of cloth-sheathed wiring could present a fire hazard and is therefore in poor condition. The full extent of wiring throughout the house could not be determined due to finish materials and therefore our analysis is limited.

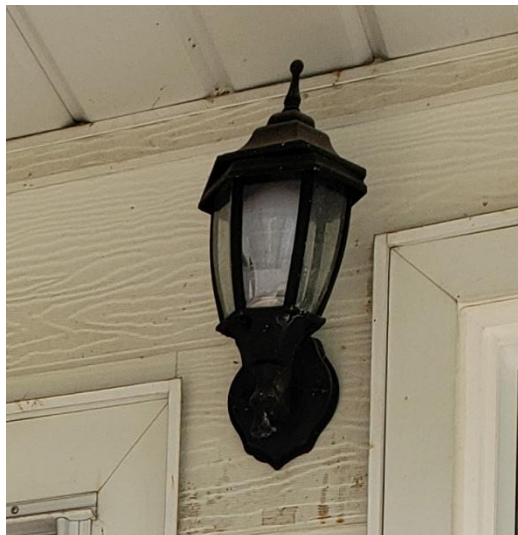
*Sconce light at the front door.*

1. Consider installing new exterior lighting that complies with Dark Sky regulations.
2. Removal of siding may reveal original light fixture locations apparent in the original wood siding. If the siding is removed and historic light fixture locations are determined, replace the exterior light fixtures with full cutoff, high-efficiency units.

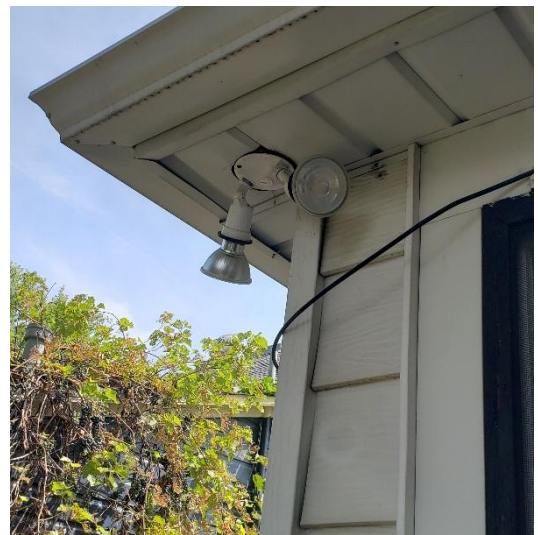
*Flood light in the northwest house corner.*
